INVESTIGATION OF THE VULNERABILITY TO
BALLISTIC ATTACK OF TWO T77 OSCILLATING TURRETS (U)
FIFTY-THIRD REPORT ON ORDNANCE PROJECT NO. TTL-5
DATES OF TEST: 10 FEBRUARY 1956 - 18 SEPTEMBER 1956

To evaluate the protection afforded against ballistic attack by two T77 oscillating turret body castings.

INVESTIGATION OF THE VULNERABILITY TO
BALLISTIC ATTACK OF TWO T77 OSCILLATING TURRETS (U)

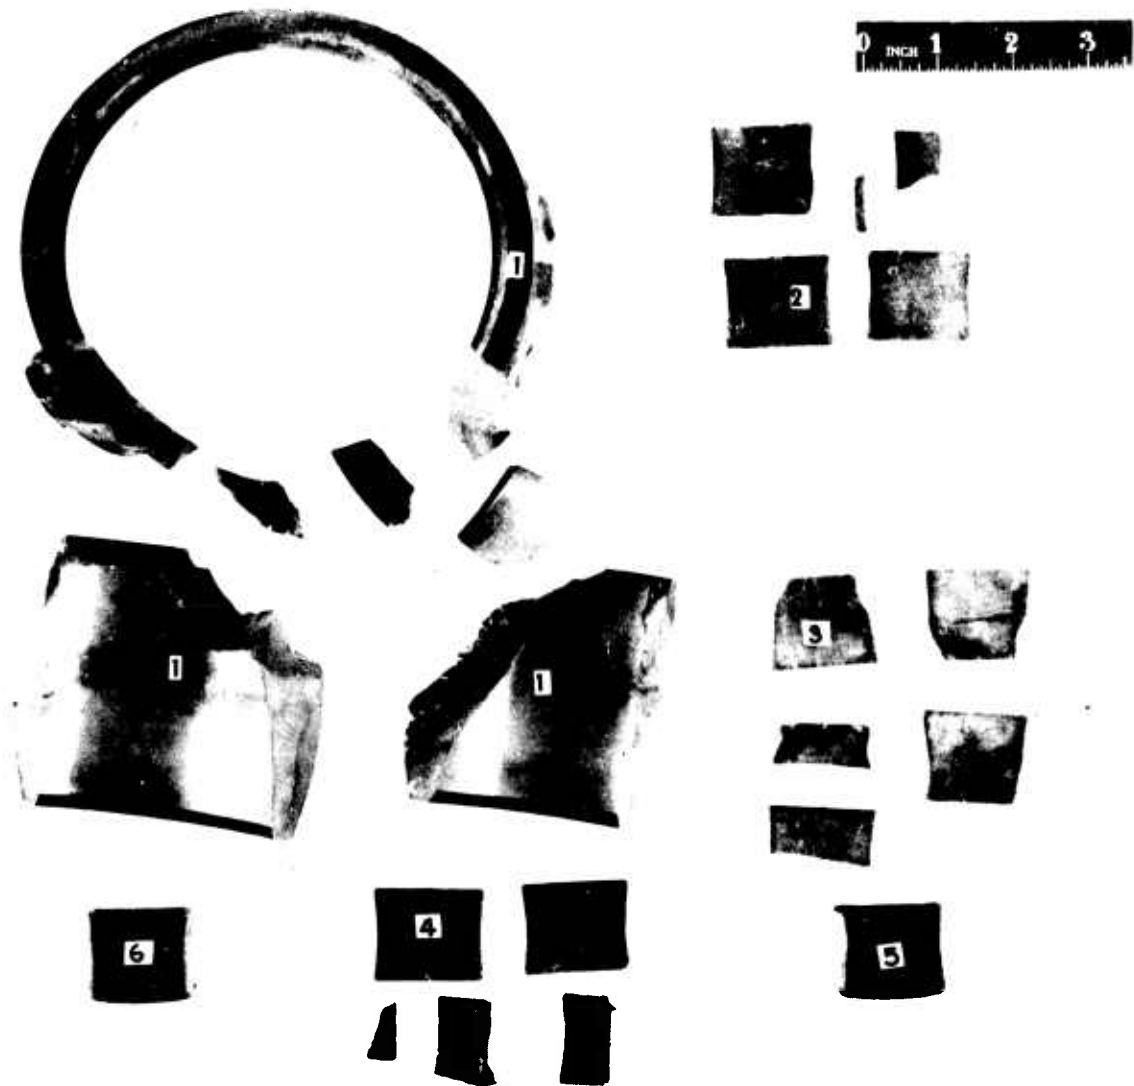
B18291: Photograph of interior damage to the left trunnion bearing after being impacted with one 90mm, AP, T33E7 Projectile at 2000 fps level. (1) Bearing race ring shattered on impact, (2-3-4) roller bearings shattered on impact, (5-6) roller bearing deformed on impact.

6. Both of the trunnion bearings were subjected to a 90° flank attack, measured 90° off the longitudinal axis of the turret, with the 90mm AP T33 projectile. The right trunnion cap was impacted at a striking velocity of 2007 fps. The turret was immobilized with no apparent damage on the interior. The left trunnion was impacted at a striking velocity of 2004 fps. An oil leak around the trunnion hub on the interior was noted. The turret was immobilized by this impact. Photograph B18291 depicts typical damage to the bearings as a result of these impacts.

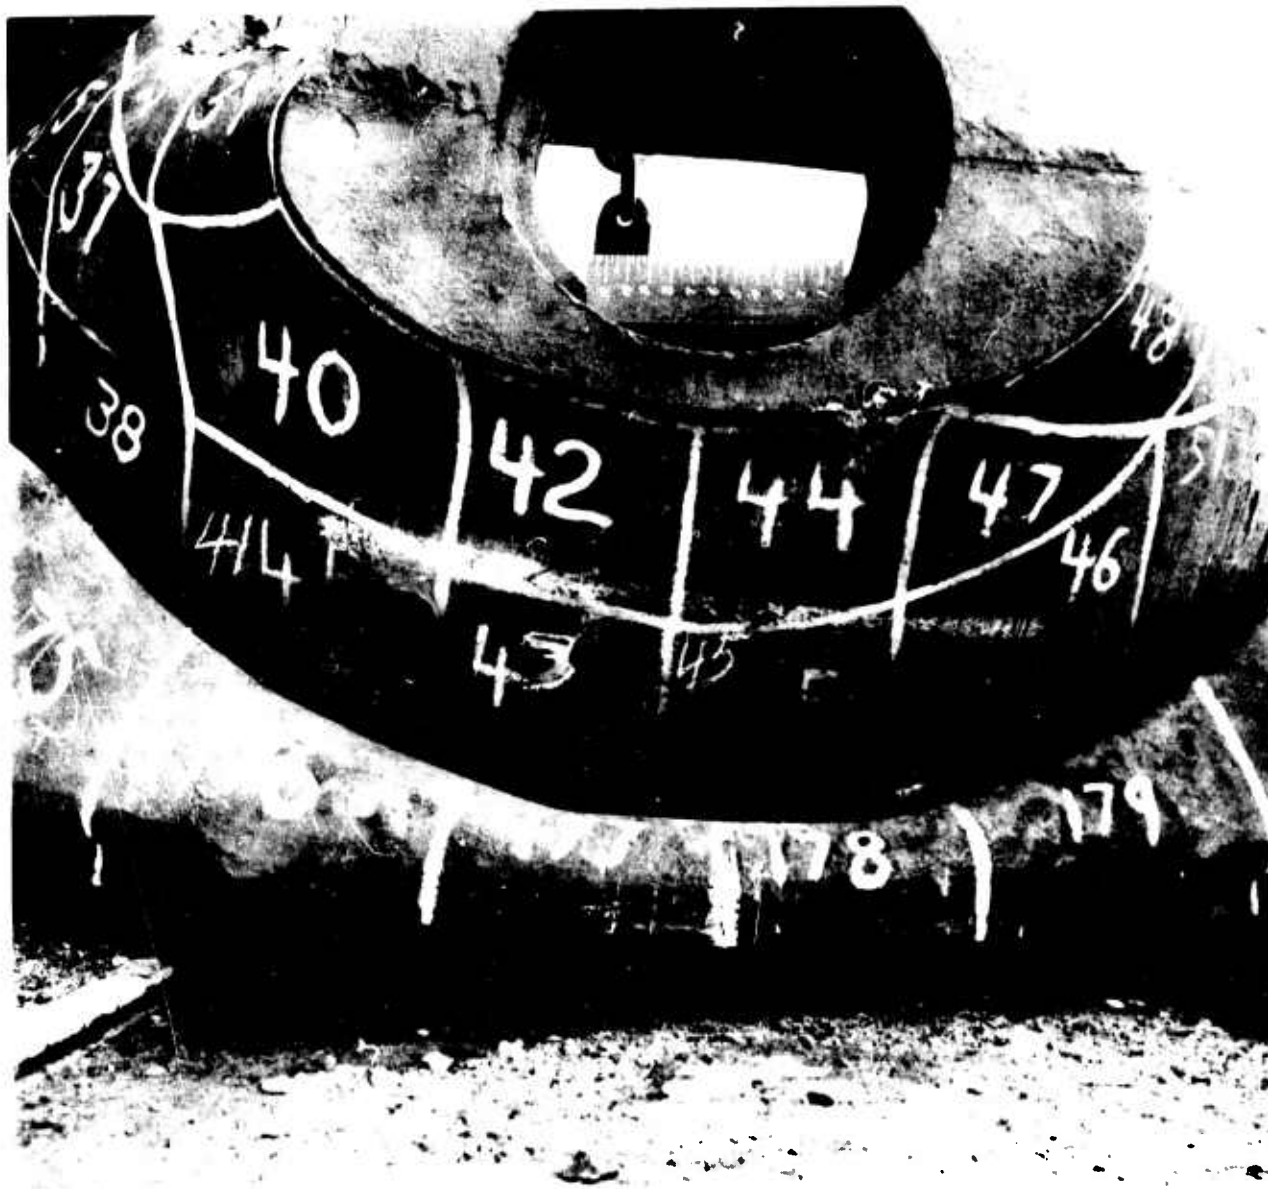
B18547: Effect of four 90mm AP T33 projectile impacts from direct front below the gun shield of the turret. Exterior view.

5. Each of the four rounds of 90mm AP T33E7 projectiles fired so as to impact in the area under the gun shield opening, with the turret in maximum elevation, resulted in complete immobilization of turret oscillation. Projectile fragments from the first round lodged between the turret body and skirting ring so tightly the body could not move. A drawbar strain gauge reading of 9375 lbs. was recorded but no movement of the turret was noted. The three remaining impacts resulted in face petalling extending over the skirting ring making it impossible to depress the turret before this petalling was removed with a cutting torch.
